I can't connect to a remote RIP on a multi-Aspen system

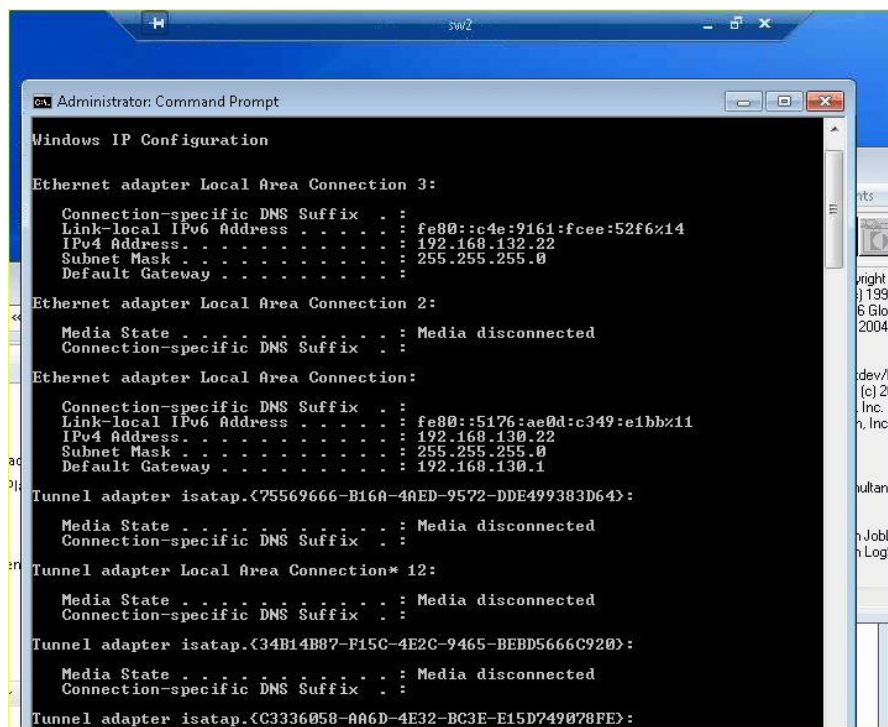
If the 1 Gb network that the RIP boxes and the Borregos talk on is not first in the order of nics, then the RIP Manager server will not be able to contact the remote SOAR RIP. This shows the 10Gb Gynea/Moby network first and the 1Gb Borrego network second:

This can be fixed through advanced network settings. Click on the tray icon:
